Historic Structures Report
Renwick Courthouse, Wallace Library, and Old Jail
City of Fredericksburg, Virginia

Created / Last Revised:
19 April 2016/ 15 June 2016

Prepared by:
Bryan Clark Green, Ph.D.
Commonwealth Architects
101 Shockoe Slip, Third Floor
Richmond, Virginia 23219

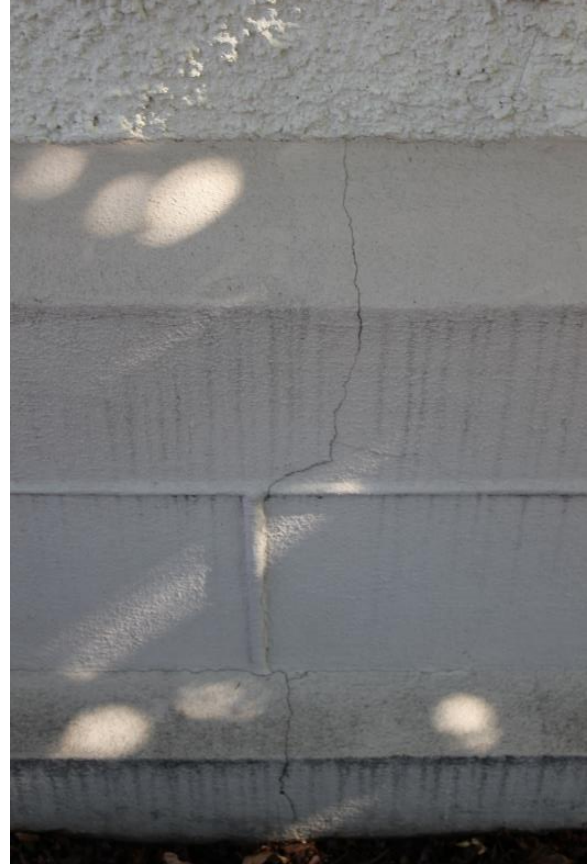
Figure 3.7, Historic Renwick Courthouse, west elevation, detail view of foundation. Note the extruded mortar joints and the vertical crack.

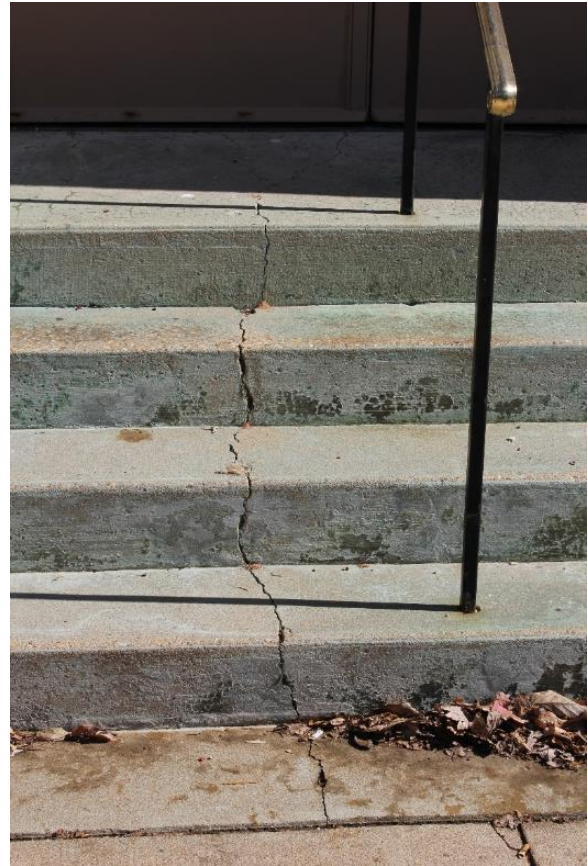
Figure 3.12, Historic Renwick Courthouse, west elevation, view of a crack at the front concrete steps.

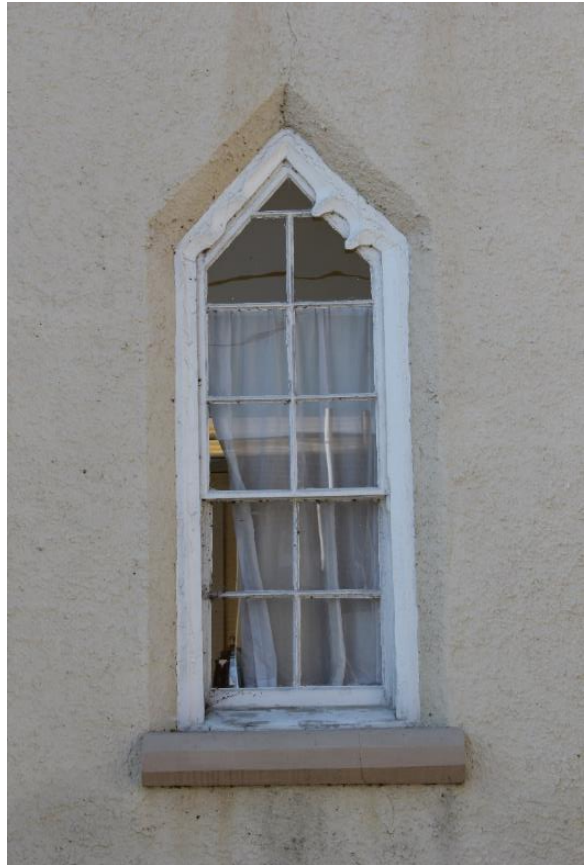
Figure 3.29, Historic Renwick Courthouse, east elevation, view of a typical first-story window; note that this window is missing part of its carved, decorative head, exhibits paint loss, and has a crack at the sill.

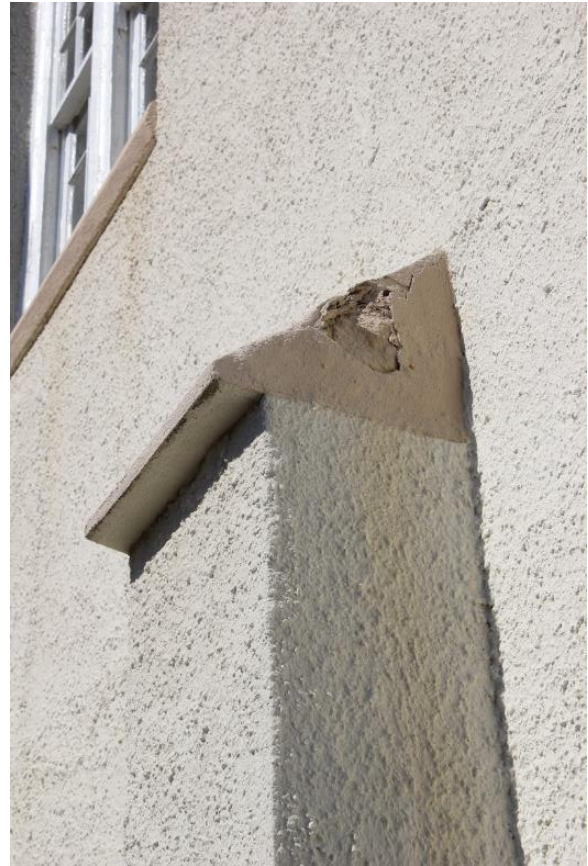
Figure 3.32, Historic Renwick Courthouse, south elevation, detail view of stucco buttress with stone amortizement. Note the damaged amortizement.

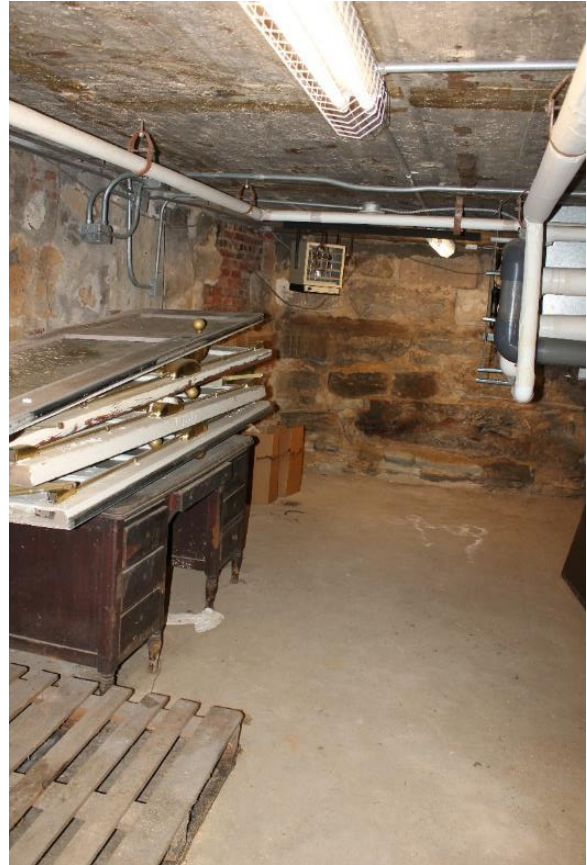
Figure 3.39, Historic Courthouse, Basement, Room 001, general view looking south. Note the deterioration of the concrete at the ceiling.

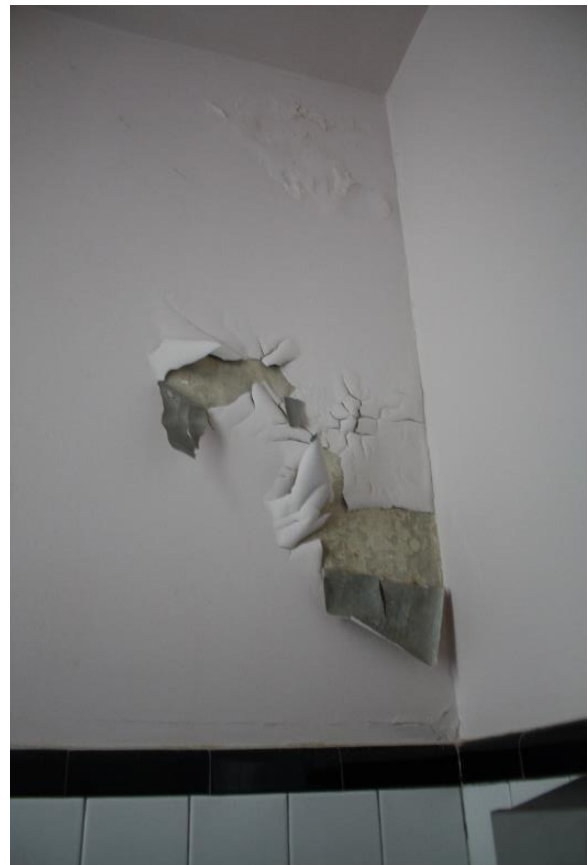
Figure 3.95, Historic Courthouse, First Floor, Room 124, view of damage to the plaster and paint at the north wall near the northeast corner of the room.

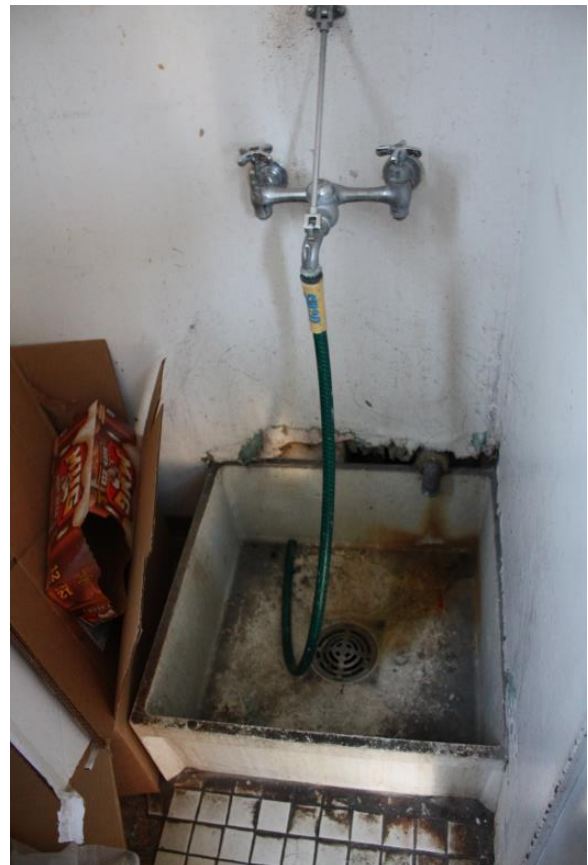
Figure 3.100, Historic Courthouse, First Floor, Room 126, view of mop sink. Note heavy soiling and rusting at sink, heavily soiled floor, and hole at the plaster wall.

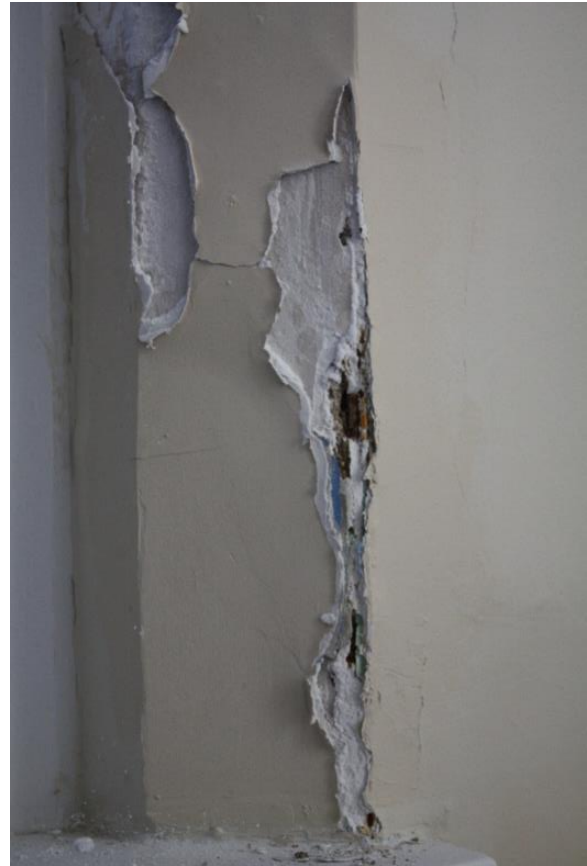
Figure 3.102, Historic Courthouse, First Floor, Room 127, view of plaster damage and efflorescence at the reveal of the easternmost window at the north wall.

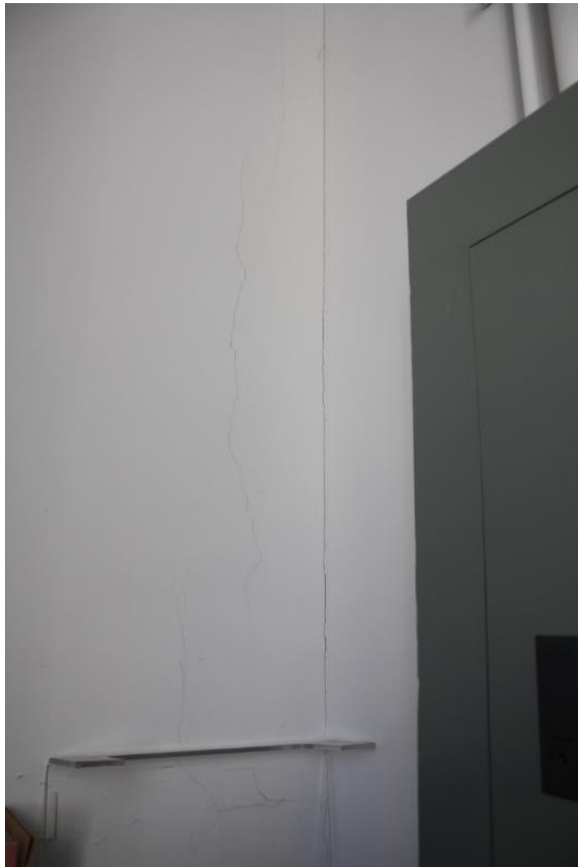
Figure 3.106, Historic Courthouse, First Floor, Room 128, detail view of vertical cracks in plaster near southwest corner of room.

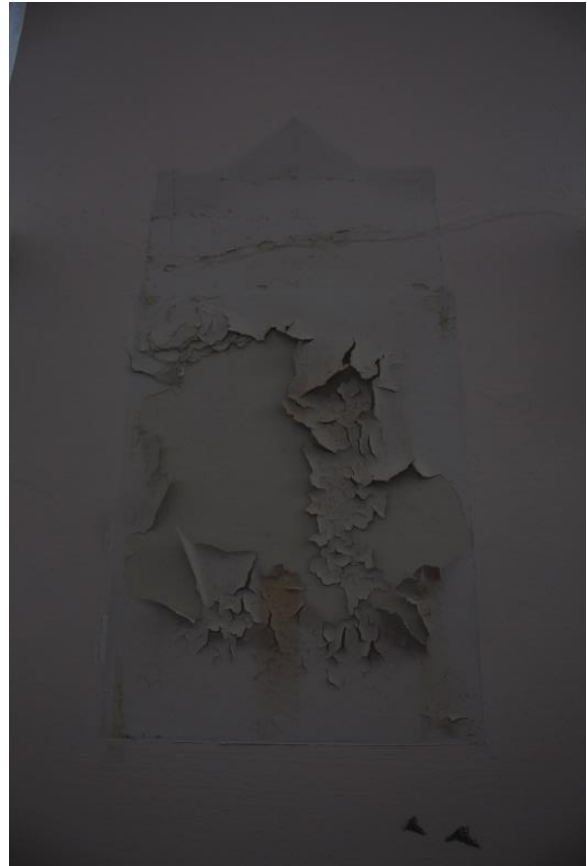
Figure 3.113, Historic Courthouse, First Floor, Room 132 (Stairway 2), view of paint failure due to moisture between the windows at the north wall.

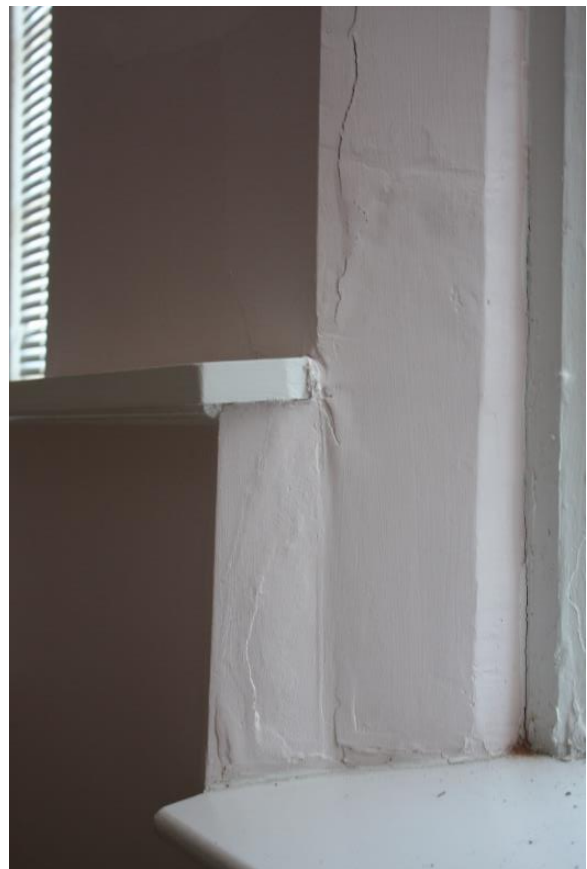
Figure 3.140, Historic Courthouse, Second Floor, Room 208, view of plaster damage at one of the window reveals.

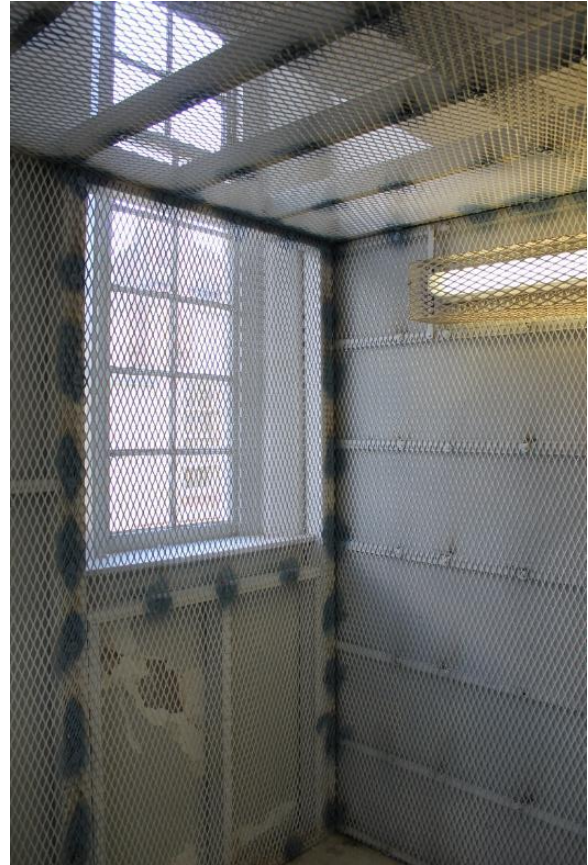
Figure 3.181, Historic Courthouse, Second Floor, Room 221, general view looking southeast. Note the area of plaster damage under the window.

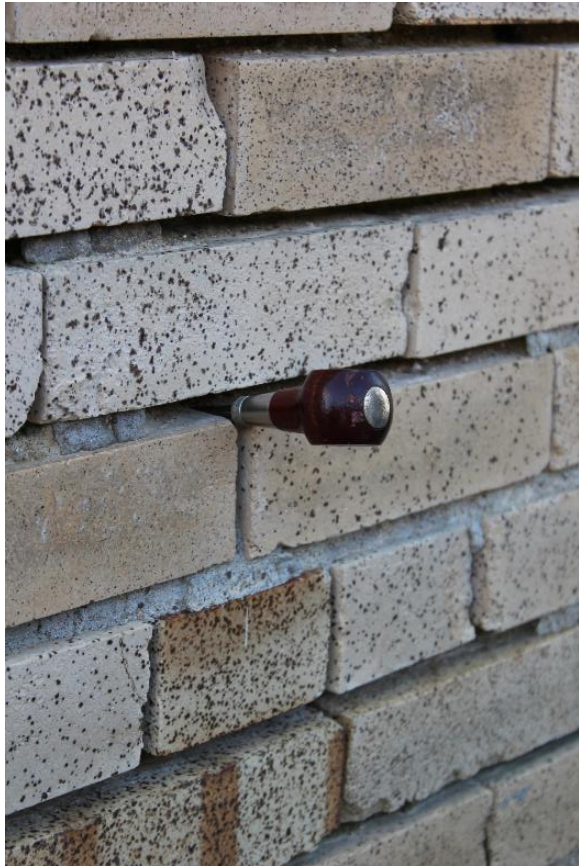
Figure 3.230, Wallace Library, East elevation, detail of brick wall. Note missing mortar.

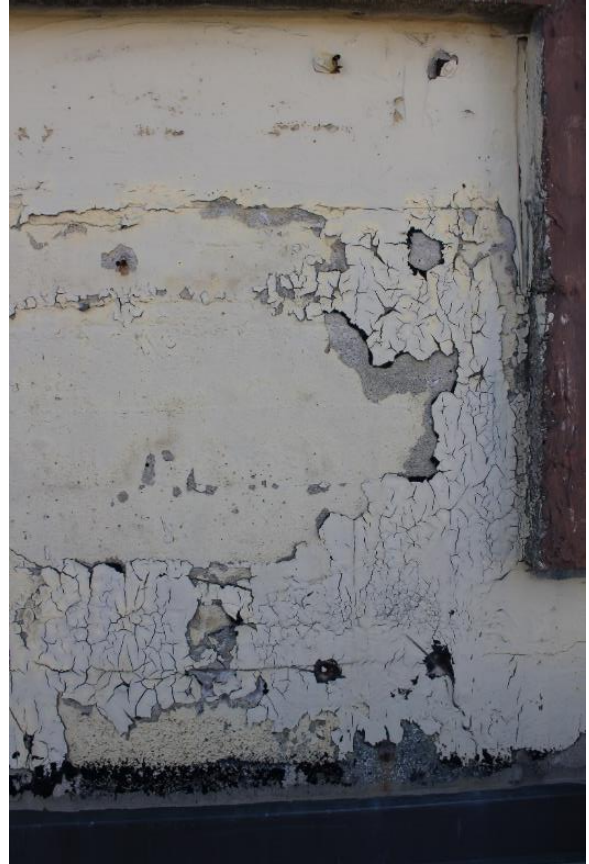
Figure 3.319, Old Jail, roof, view of paint deterioration at transition between low and high roof.

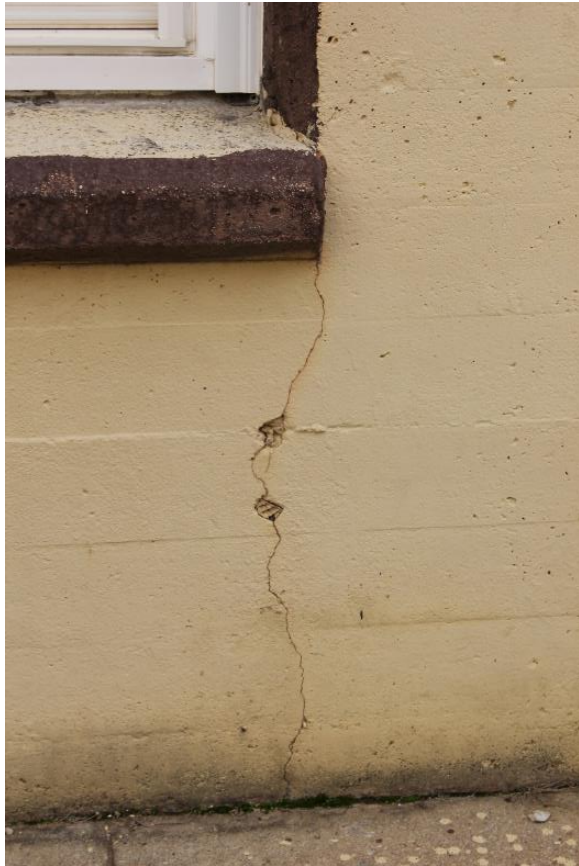
Figure 3.324, Old Jail, west elevation, view of a crack underneath the first-story window south of the northernmost door.

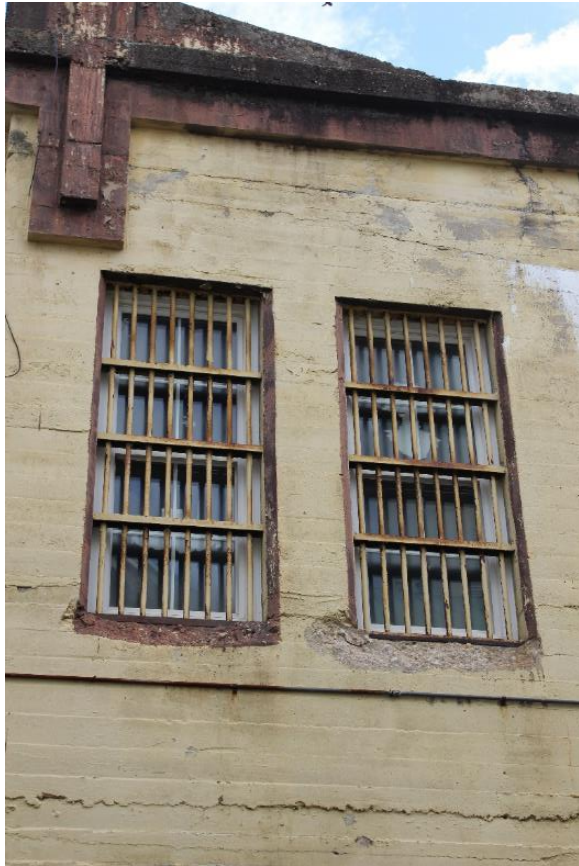
Figure 3.326, Old Jail, west elevation, view of typical second-story windows at the high-roofed south section. Note the concrete spalling where the sills are missing.

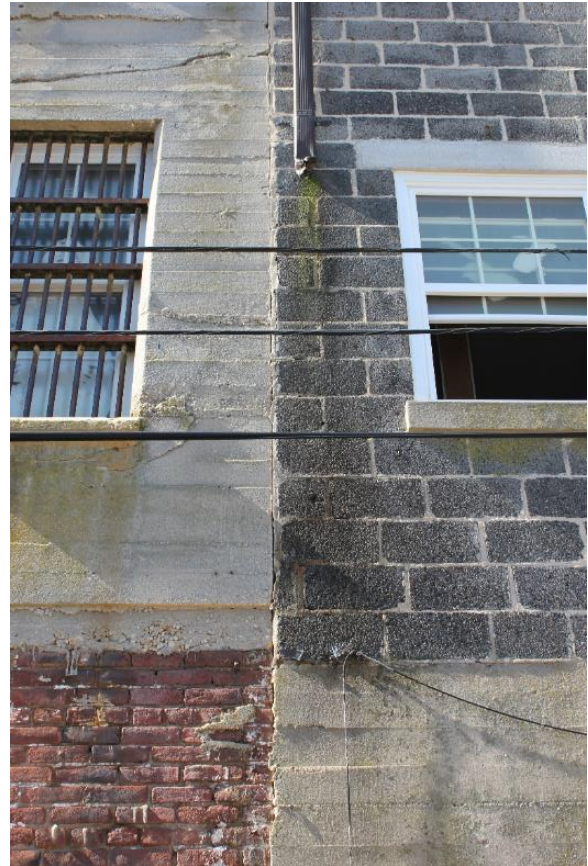
Figure 3.338, Old Jail, east elevation, view of intersection of high- and low-roofed sections at the north end of the building. Note the mix of building materials and the damaged, truncated downspout.

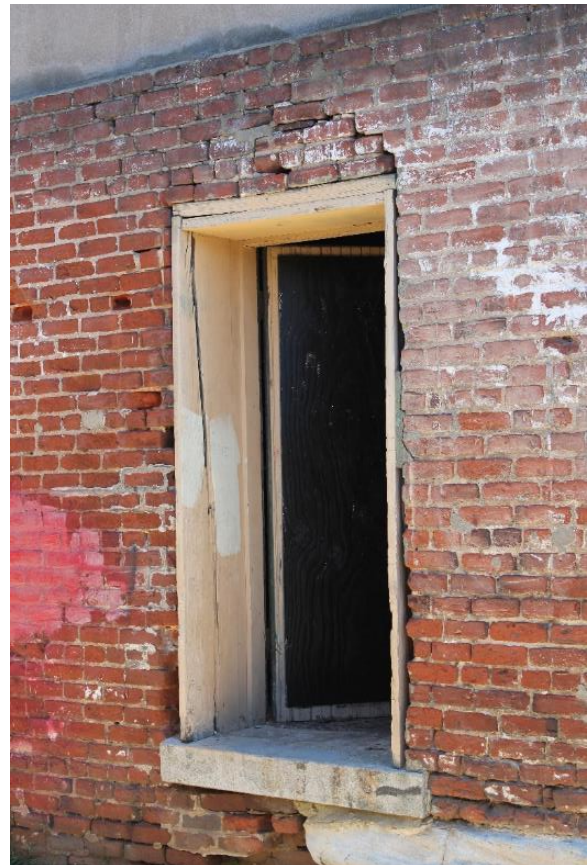
Figure 3.346, Old Jail, east elevation, view of south door at one-story wing. Note the large vertical crack in the door frame, the lack of steps to access the door, and step cracks at the brick wall above the door.

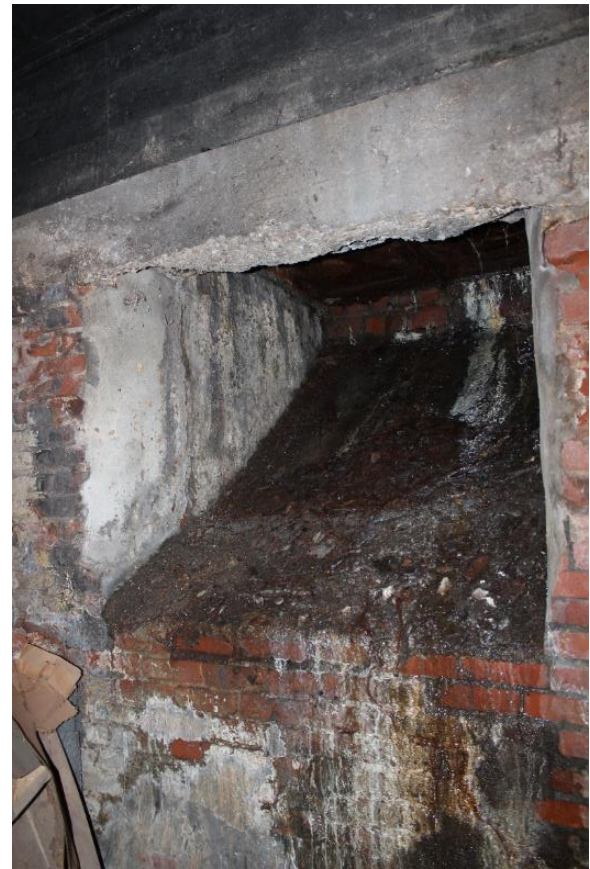
Figure 3.357, Old Jail, Basement, Room 001, view of the coal chute at the west wall. Note that the chute is heavily soiled and there is moisture staining at the wall below.

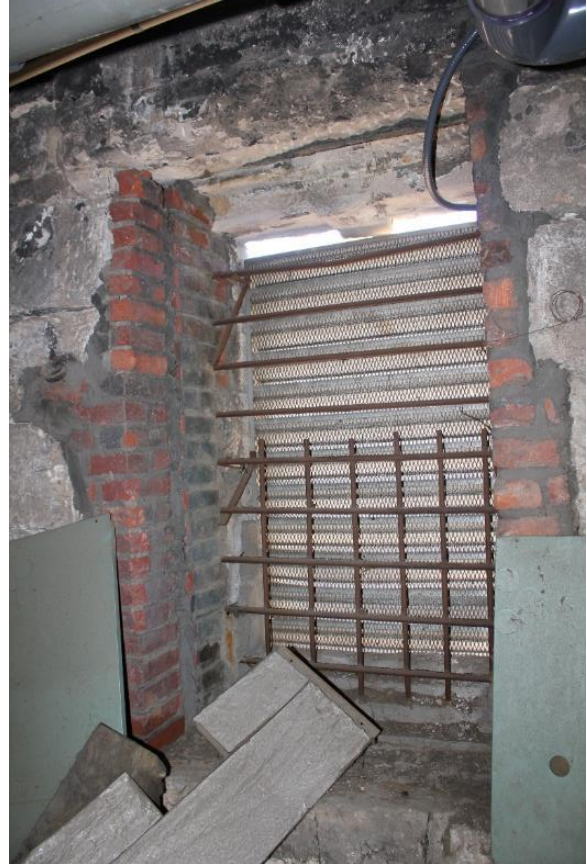
Figure 3.362, Old Jail, Basement, Room 003, view of a mechanical grille and metal bars at the east wall; note that the bars are rusted.

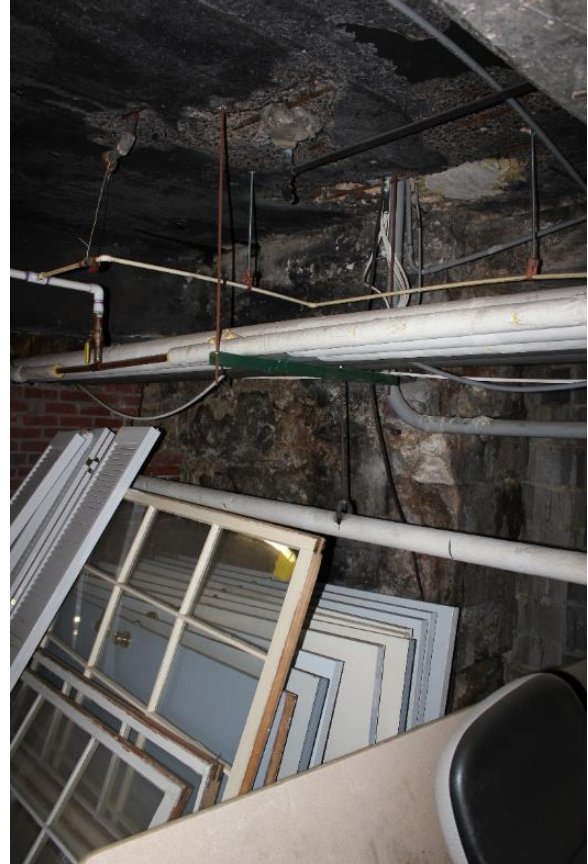
Figure 3.365, Old Jail, Basement, Room 003, general view looking southwest. Note the area of concrete block wall, which exhibits efflorescence and moisture staining.

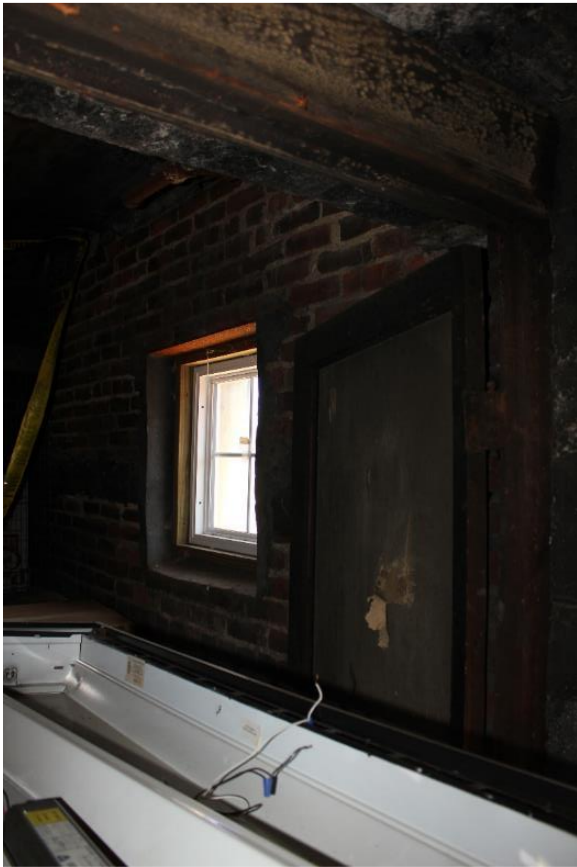
Figure 3.368, Old Jail, Basement, Room 003, view of the four-light, square, vinyl replacement window at the east wall and the adjacent interior door. Note the area of loss at the door.

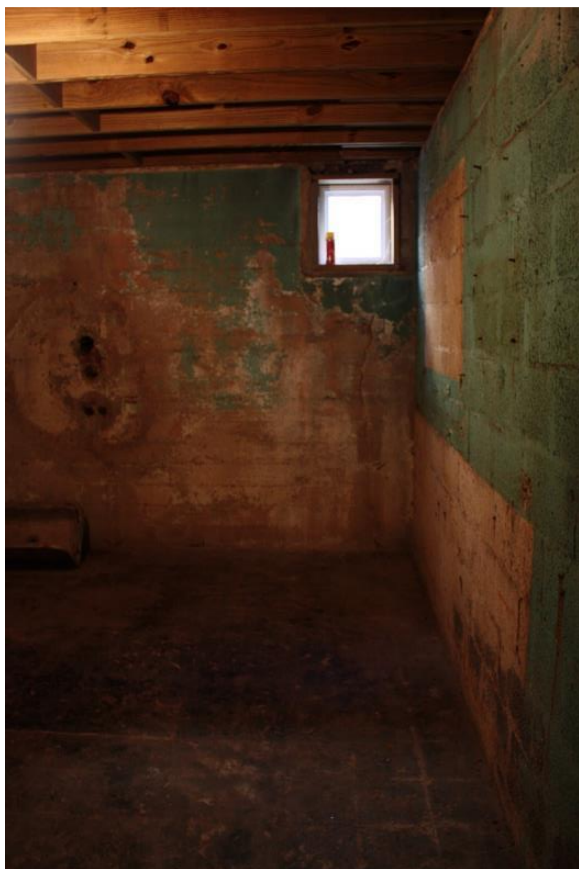
Figure 3.377, Old Jail, Basement, Room 005, general view looking north. Note the single square, vinyl replacement window and holes at the north wall; the large areas of paint loss at each wall; and the heavily soiled floor.

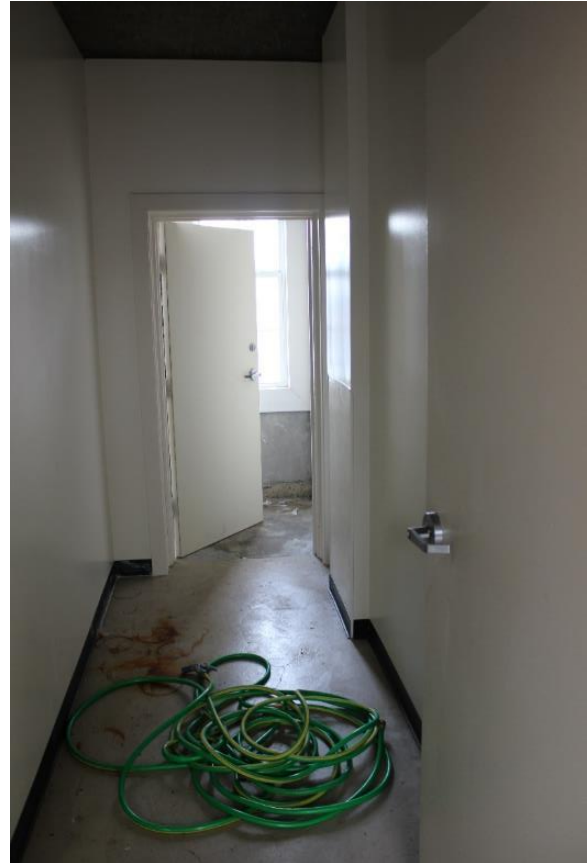
Figure 3.398, Old Jail, First Floor, Room 104, general view looking east. Note the rust stains at the floor.

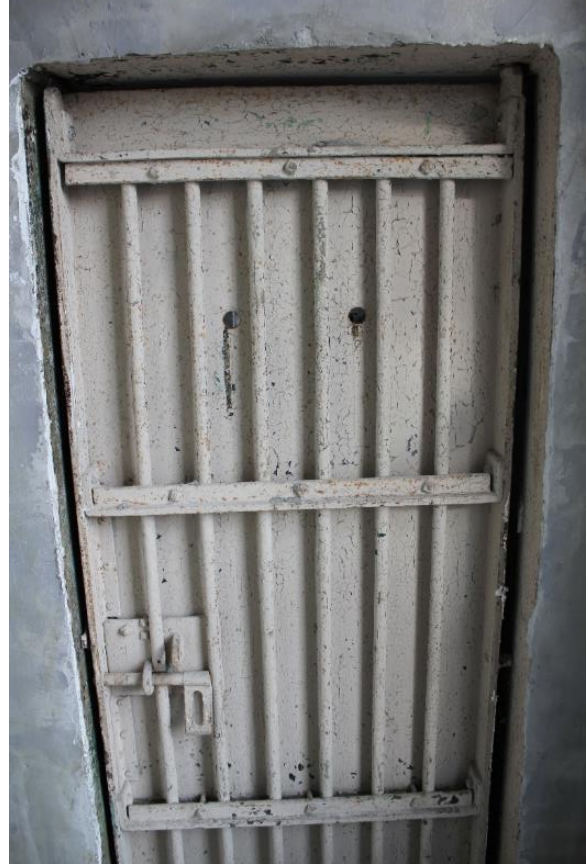
Figure 3.402, Old Jail, First Floor, Room 104, view of the jail cell door at the north wall of the east vestibule. Note the paint crazing and rusting throughout.

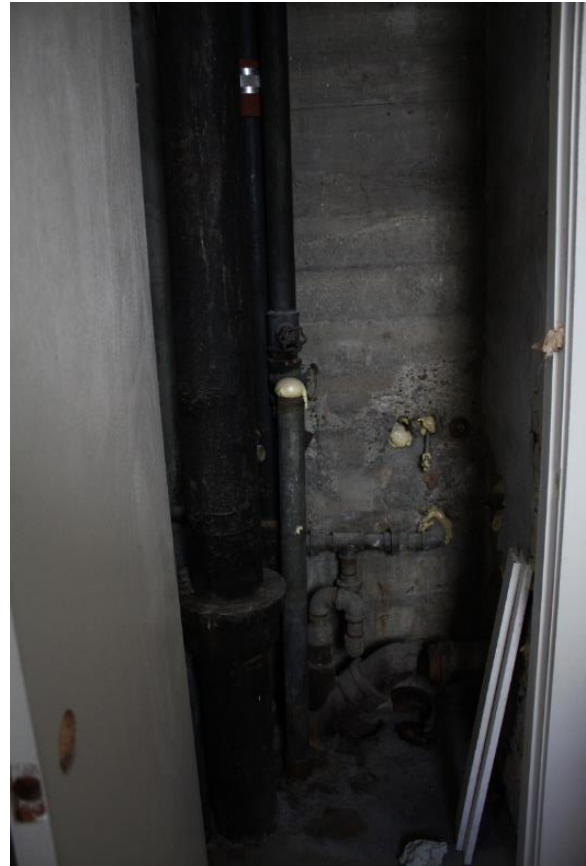
Figure 3.409, Old Jail, First Floor, Room 105, view inside unfinished closet at east wall containing plumbing for the adjacent jail cells. Note the missing knob at the hollow-core door.

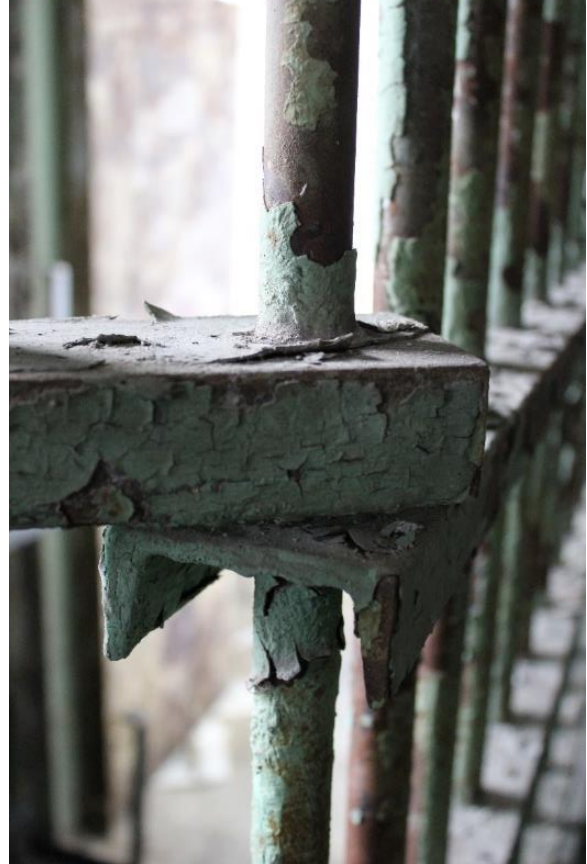
Figure 3.414, Old Jail, First Floor, Room 106, detail view of heavy paint loss and rust at metal bars.

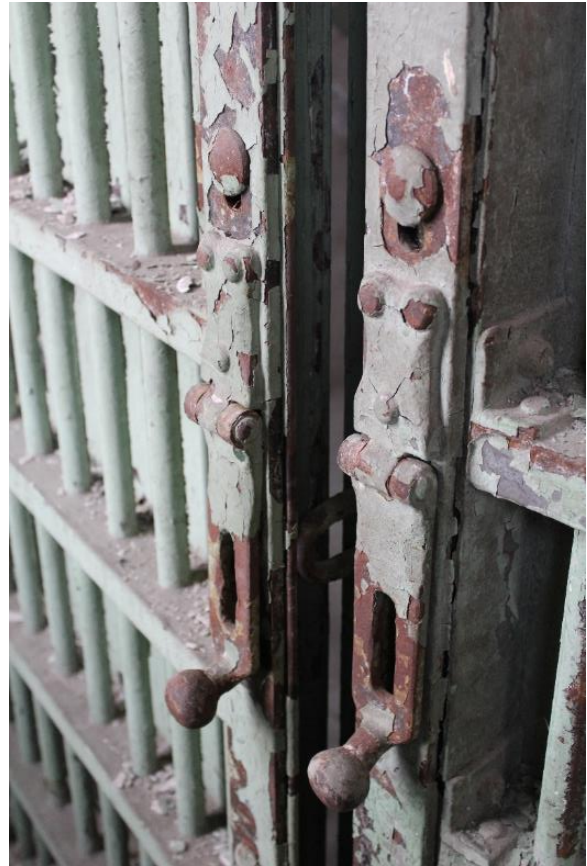
Figure 3.419, Old Jail, First Floor, Room 107, detail view of jail cell doors. Note the heavy paint loss and rust.

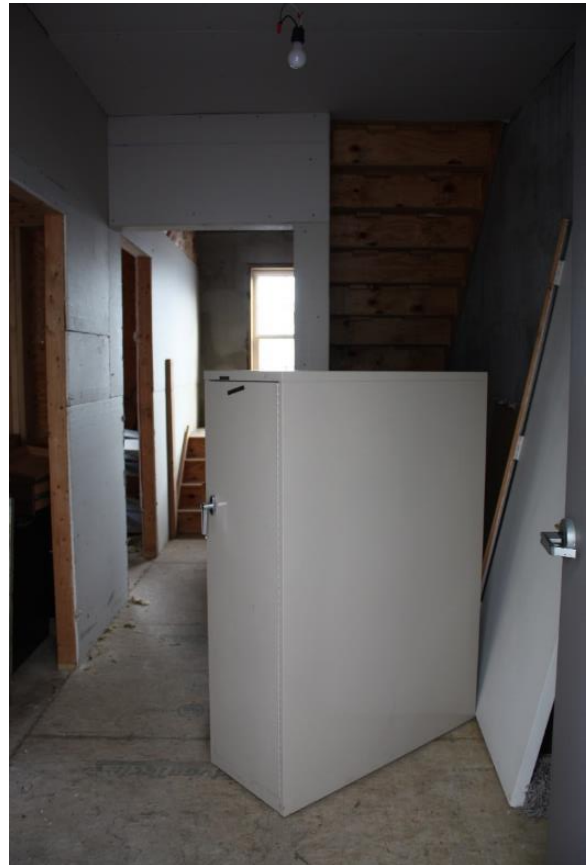
Figure 3.425, Old Jail, First Floor, Room 109, general view looking east. Note the unfinished state of the room.

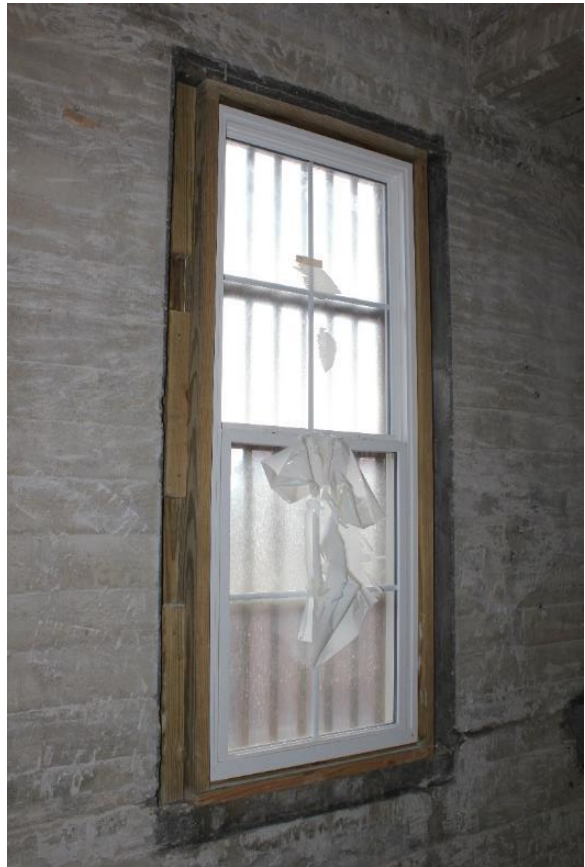
Figure 3.443, Old Jail, Second Floor, Room 201, view of a typical four-over-four vinyl replacement window. Note the remnants of a plastic covering at the sash, a typical condition at other windows.
